Manhole Inspection Summary

Manhole # S43AA_031MH

Record Plat: **43AA** Node: **031** Status: **Found**

Location Address: **811 n bond st**

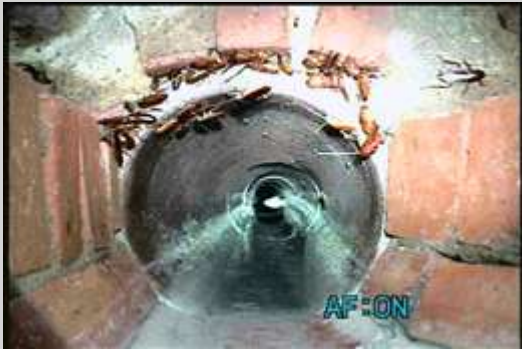
12 O'Clock Outflow

8 in. Circular Gravity Sewer
Pipe Out @ 12 O'Clock

Pipe Material: **Clay** ☐ Pipe Lined

Invert Depth: **9.41** (ft.) Flow Characteristics: **Fast**

Infiltration: **None** Pipe Seal Cond: **Unknown**

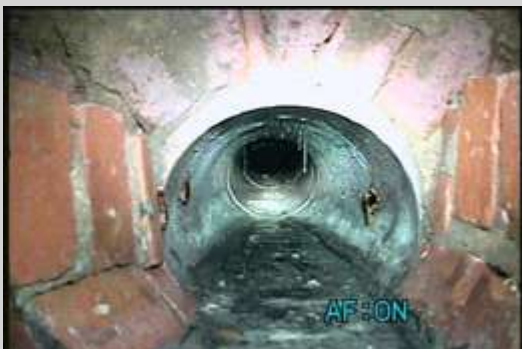
3 O'Clock Inflow

8 in. Circular Gravity Sewer
Pipe In @ 3 O'Clock

Pipe Material: **Clay** ☐ Pipe Lined

Invert Depth: **9.38** (ft.) Flow Characteristics: **None**

Infiltration: **None** Pipe Seal Cond: **Unknown**

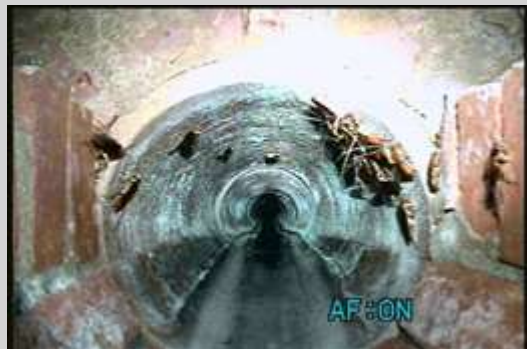
6 O'Clock Inflow

8 in. Circular Gravity Sewer
Pipe In @ 6 O'Clock

Pipe Material: **Clay** ☐ Pipe Lined

Infiltration: **None** Pipe Seal Cond: **Unknown**
